THERMAL AGING OF SILVER-PLATED COPPER AIRCRAFT
ELECTRICAL WIRE

MAY 1973

AFML-TR-73-113

L. R. BIDWELL

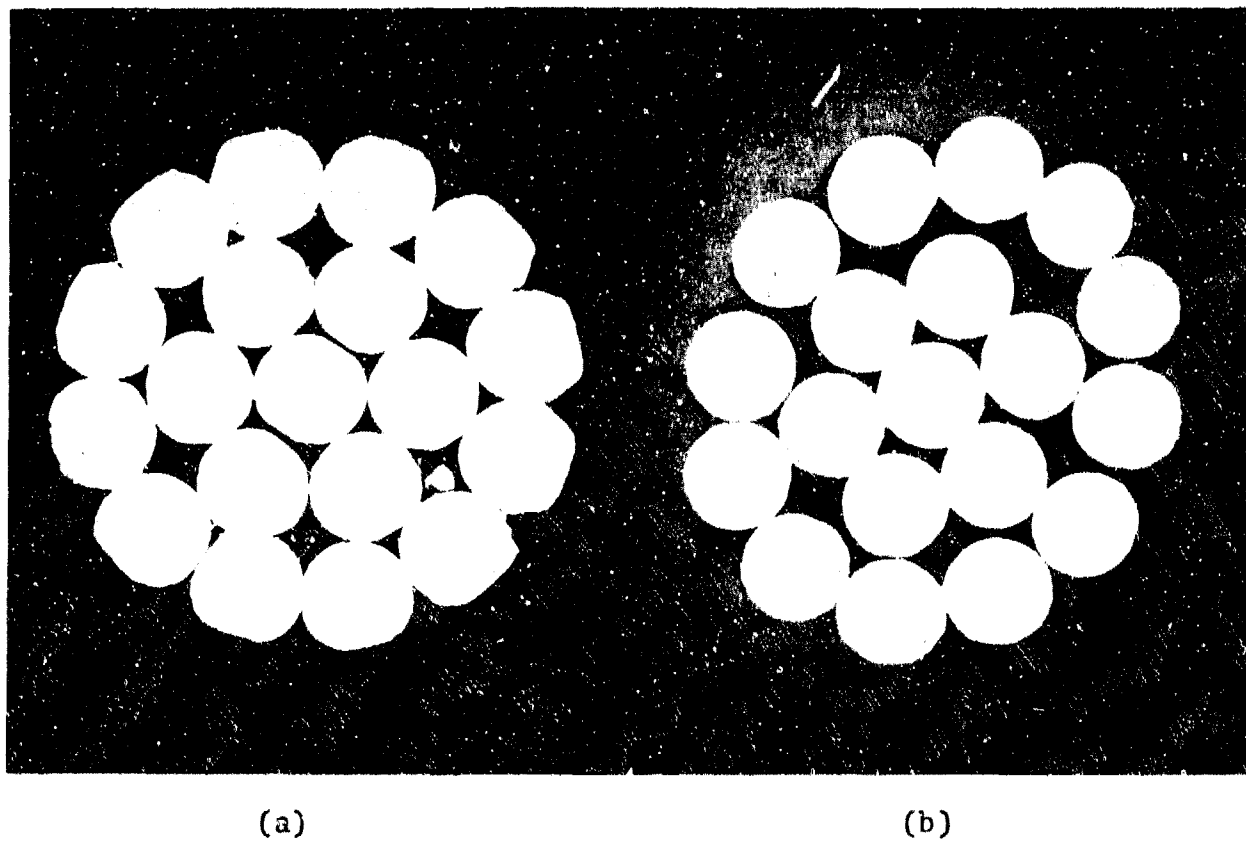
Figure 1 shows full cross-sectional views of unaged unilay and concentric stranded wire. The results of drawing the wire through a die in order to achieve diameter tolerances are clearly evident in Fig. 1a. The individual strands have been deformed considerably and the radial interstrand contact area, particularly in the outer strands, has been markedly increased. What would normally be a simple longitudinal line contact of adjacent strands is now, in effect, a longitudinal contact surface of significant width. Conditions are thus made ideal for strand blocking at elevated temperatures through the interdiffusion of silver between adjacent strands.

Figure 1. Cross-sectional views of unaged wire. (a) No. 20 (19/32) Kapton insulated unilay wire, X65. (b) No. 18 (19/30) Teflon insulated concentrically stranded wire, X50.

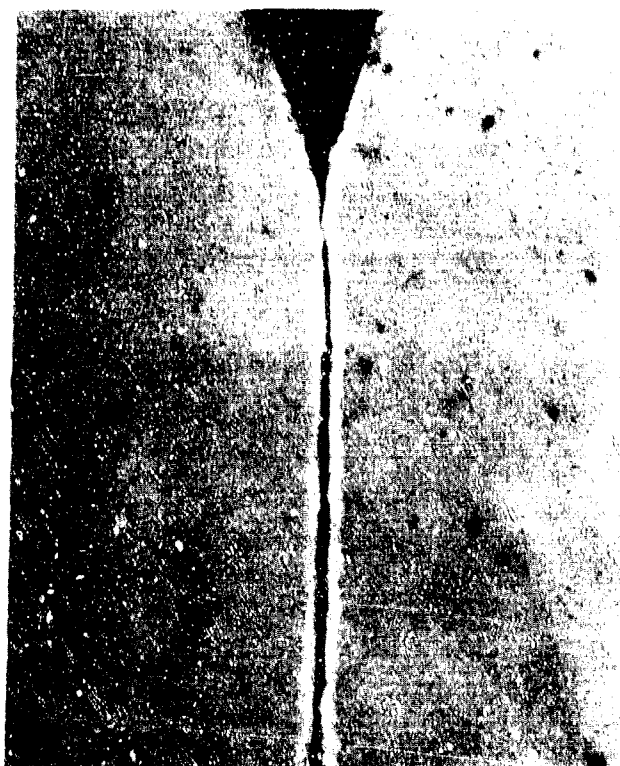
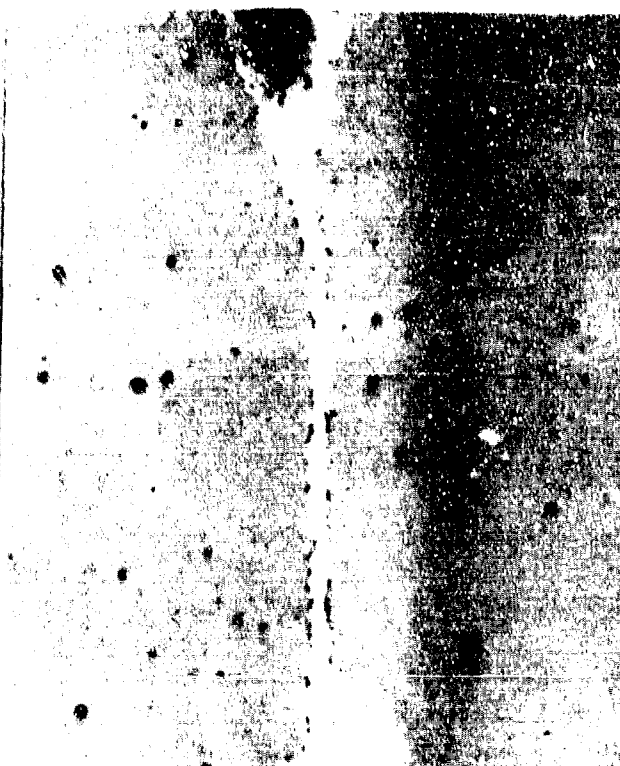
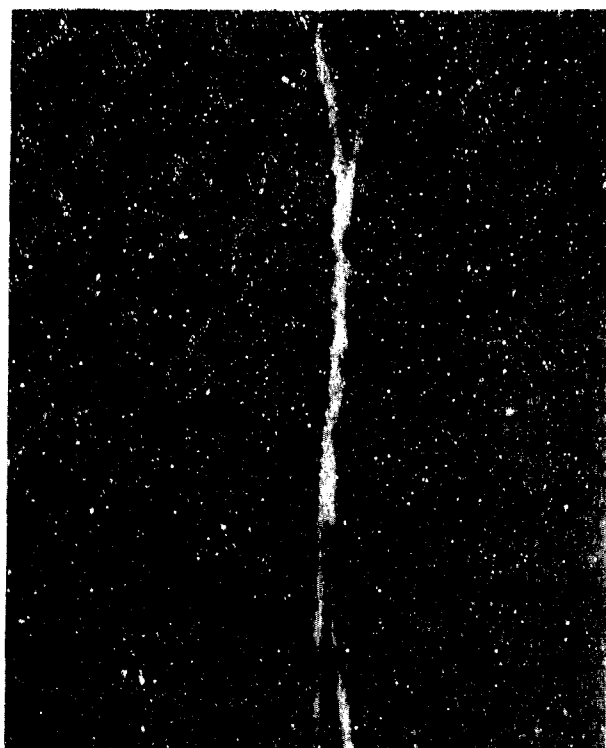
The most striking features seen in Figs. 2-4 are the obvious formation of a reaction product at the copper/silver interface and an equally obvious degradation of the silver plating. The extent to which the latter has occurred can be seen more clearly in the SEM photographs of the longitudinal wire surface shown in Figs. 5-7. The beaded or globular appearance of the surface material gives the impression that a process similar to incipient melting has taken place.

Figure 2. Cross sections of No. 20 (19/32) Kapton insulated unilay wire unaged and aged at 150°C, X1200. (a) Unaged. (b) 500 hrs. (c) 1000 hrs.

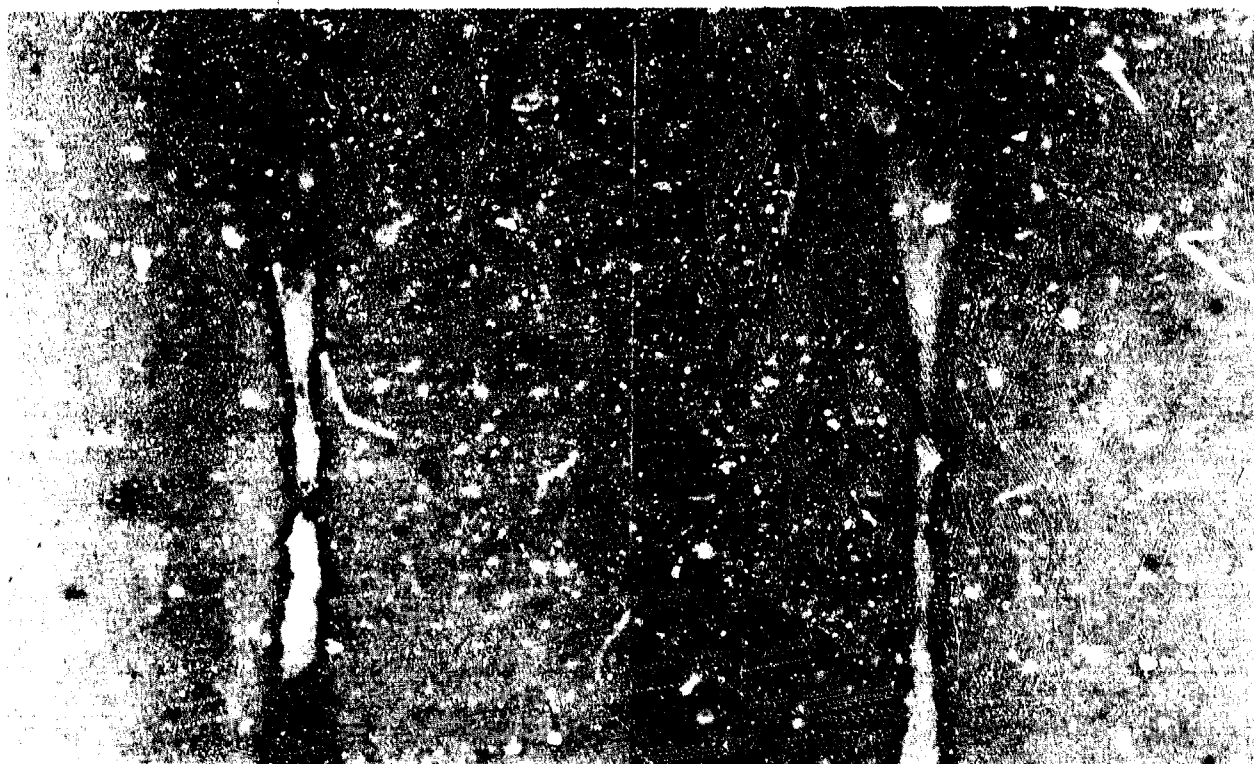
Figure 3. Cross-sections of No. 20 (19/32) Kapton insulated unilay wire aged at 200°C, X1200. (a) 500 hrs. (b) 1000 hrs.

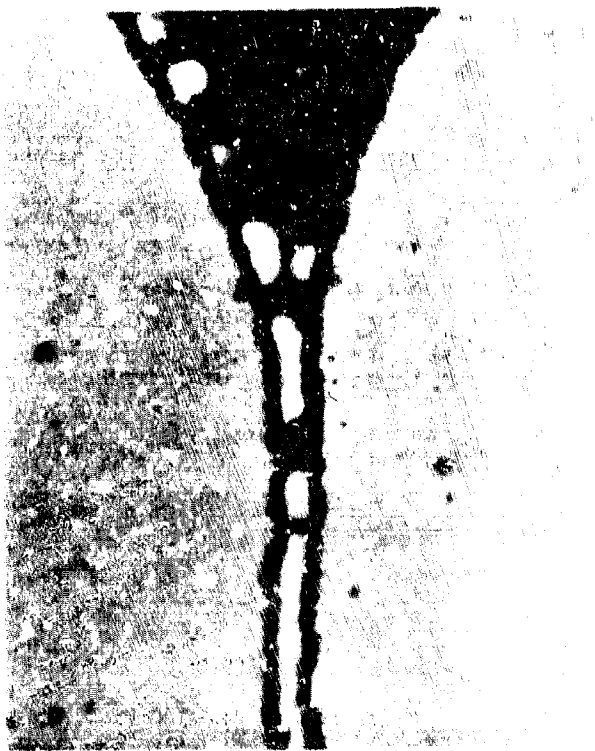
Figure 4. Cross-sections of No. 20 (19/32) Kapton insulated unilay wire aged at 230°C, X1200. (a) 125 hrs. (b) 264 hrs. (c) 500 hrs.

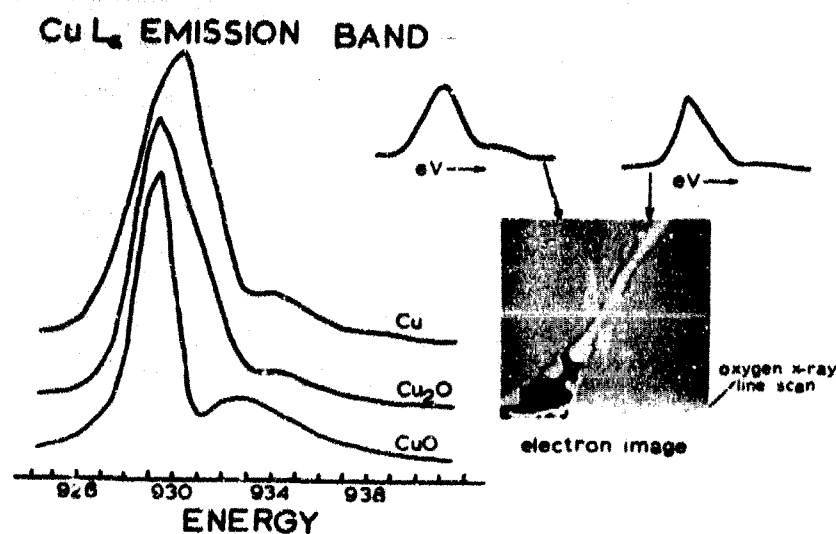
the copper/silver interface is a simple compound of copper and oxygen. Figures 9a and b show the changes in the intensity of the characteristic copper and oxygen X-rays emitted from various points along a scan through an interstrand boundary. The location of the scan trace is nominally represented by the heavy white line superimposed on the reversed-polarity back-scattered electron image of the sample. Numerous cursory scans failed to reveal the presence of any additional elements of significance other than the silver plate between the copper oxide layers and a number of iron-base impurities that occurred well within the copper strands. The oxygen X-ray intensity originating from the silver layer is quite low, indicating that this material is primarily silver metal and not silver oxide (Ag_2O).

Figure 9. Electron microprobe scans of No. 20 (10/32) Kapton insulated unilay wire aged 500 hrs at 230°C. (a) Reverse electron image with Cu K_α X-ray emission scan, X2880. (b) RE image with O₂ K_α X-ray emission scan, X1440. (c) Cu L_α X-ray emission band profile for Cu, Cu₂O, CuO.

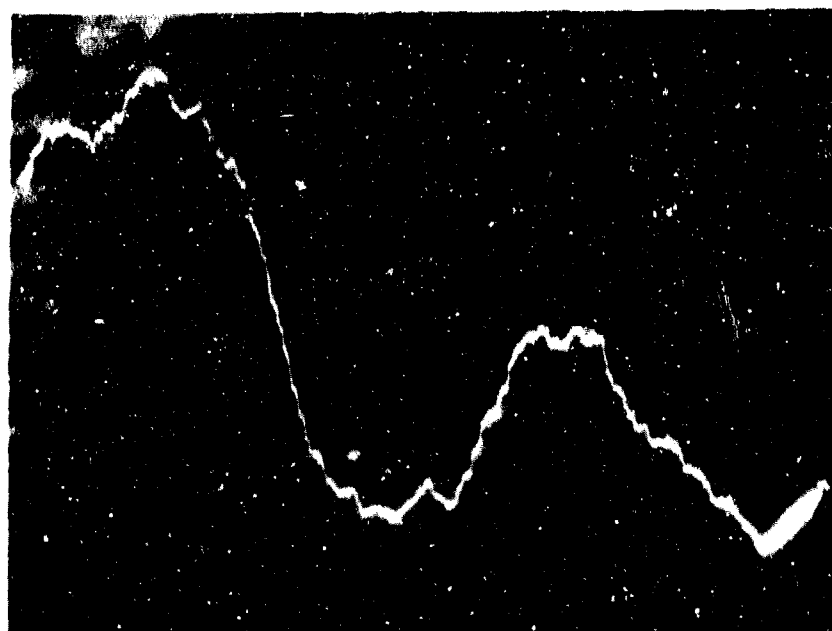
The appearance of the aged, stripped wires was quite surprising. The outer strands, at least, did not show any evidence of the silver spheroidization observed on insulated wires but appeared to be covered with an oxide. The morphology of the oxide was quite varied. Figure 13a illustrates an area typical of a large fraction of the surface. Furrowed regions, nodules, and a few whiskers can be seen. Figure 13b shows a higher magnification view of a furrowed region. Superimposed on this photograph is a copper K_{α} X-ray emission scan which was made horizontally across the surface through the white dot seen in the lower center of the picture. Following the course of this scan through the dot shows that the overlying material is copper-rich. Figure 14 depicts a region containing mostly nodules. The X-ray scans through the white dots in the center of these photographs shows that the nodules are copper-rich while the background material is silver-rich. Oxygen X-ray scans of the furrowed regions (Fig. 13) and the nodules (Fig. 14) reveal that both are copper oxide. Figure 15 shows two types of whisker colonies. In Fig. 15b, the whiskers can be seen growing out of the nodules.

Figure 13. Surface of No. 20 (19/32) Kapton insulated unilay wire aged 500 hrs at 200°C with insulation removed prior to aging. (a) Typical surface of outer strands, X1600. (b) X5000 with superimposed CuK α X-ray emission trace.

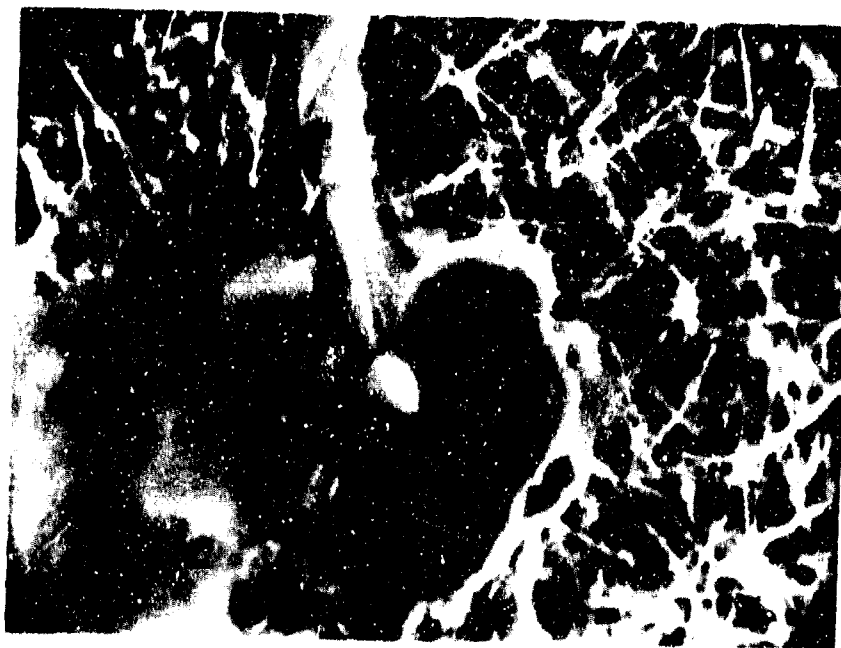
Figure 17. Surface of AWG 28 uninsulated solid wire aged 2000 hrs at 200°C by the Hudson Wire Co. (a) X500. (b) Same area, X2500.

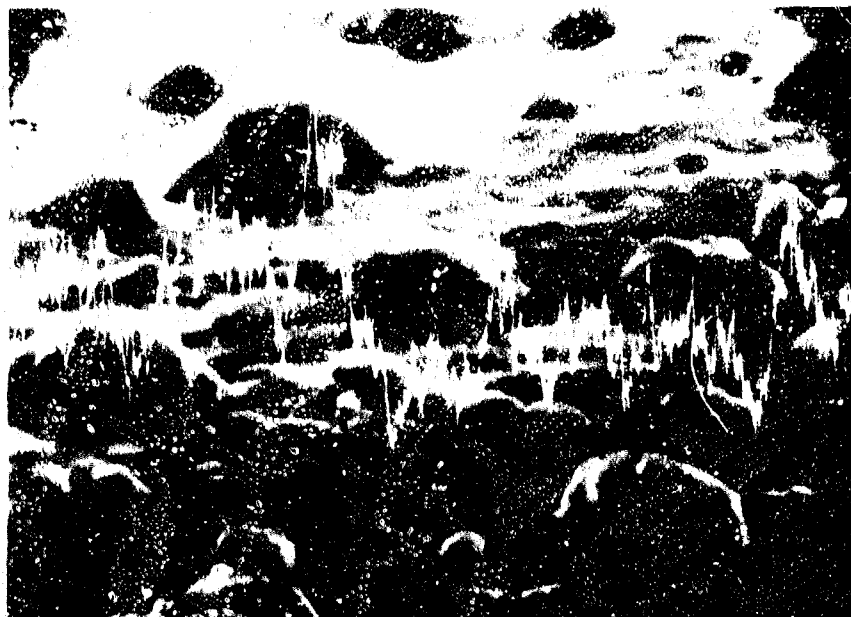
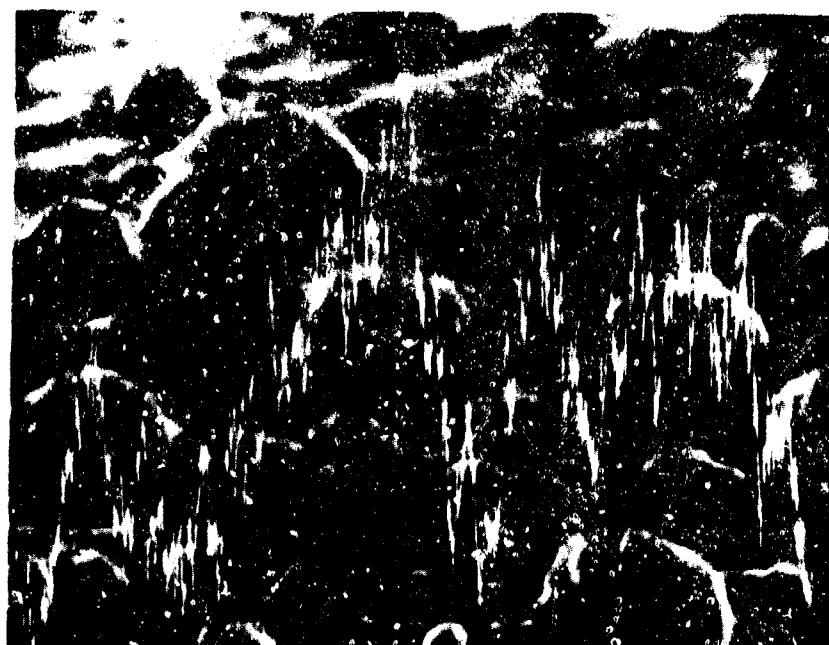
Examination of the inner strands of the aged, stripped wires revealed spheroidization of the silver similar to that seen in the aged, insulated wires. The surface of an inner strand is shown in Fig. 19. CuK_α and AgK_α X-ray scans through the white dots located in the center of the photographs show that the globules are silver-rich and not the same as the copper-rich nodules noted on the outer strands (Fig. 14). Apparently, when the availability of oxygen is restricted, the spheroidization process can occur. In the presence of free flowing air, however, the rapid formation of a copper oxide layer overlying the silver prevents spheroidization.

Figure 19. Surface of No. 20 (19/32) Kapton insulated wire aged 500 hrs at 200°C with the insulation removed prior to aging. X-ray emission scans superimposed on structure of inner strands, X5000. (a) CuK_α . (b) AgK_α .

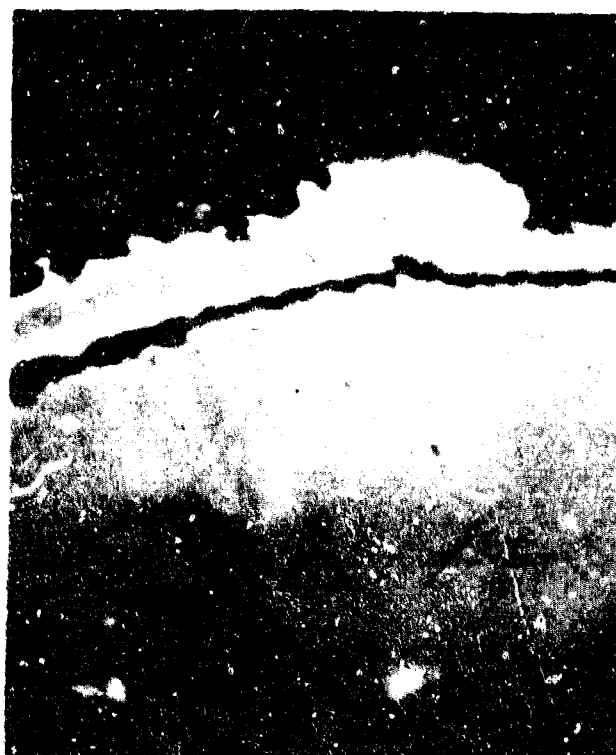
The mechanism by which a copper oxide layer is deposited or grown on the outside surface of the silver plating is not clear. Cross sections of oxidized strands (see Fig. 20) reveal that breaks in the silver plate are often present and that the region underlying the silver is sometimes oxidized (Fig. 20a), but more frequently is cavitated (Figs. 20b,c). Readers acquainted with the so-called 'red plague' corrosion of silver-plated copper wires⁸ will note a similarity in the appearance of that phenomenon and the cross-sectional views of Fig. 20. 'Red plague' is normally attributed to the galvanic attack of copper at existing breaks in silver plating in the presence of moisture and oxygen. The plating defects are presumed to occur during the manufacturing process.

Figure 20. Cross sections of No. 20 (19/32) Kapton insulated wire aged 500 hrs at 200°C with the insulation removed prior to aging. (a,b) Light photomicrographs, X1200. (c) SEM photomicrograph, X2500.

3. In wire stripped of its insulation, as would be typical of termination points, the deterioration is characterized by the growth of bulk copper oxide and whiskers on the outside surface of the silver coating and a cavitation of the underlying copper. This type of phenomenon has the appearance of a mild form of 'red plague' galvanic corrosion. 'Red plague' is ruled out as a cause, however, due to the absence of a suitable electrolyte at elevated temperature. It is thought, instead, that the incursion through the protective silver layer may be related to the presence of contaminated regions containing sulfur, chlorine, and carbon that were identified by electron microprobe analysis. This is followed initially by oxidation of the underlying copper and eventually by the diffusion of additional copper to the surface where it is oxidized to form a surface oxide layer. Regardless of its cause, the resulting cavity and its overlying silver layer constitute an ideal site for galvanic corrosion at ambient temperature if the region is exposed to moisture and oxygen. Since the attack would be highly localized and ultimately end in the rupture of the conductor, it is recommended that wire terminations exposed to thermal aging be sealed.
